Morphology, Dynamics and Hazard Management of the New River Lagoon, Westland, New Zealand

A thesis submitted in partial fulfilment of the
requirements for the Degree of
Master of Science in Geography
at the
University of Canterbury

Michael J. Fifield

**Department of Geography
University of Canterbury
Christchurch, 2012**

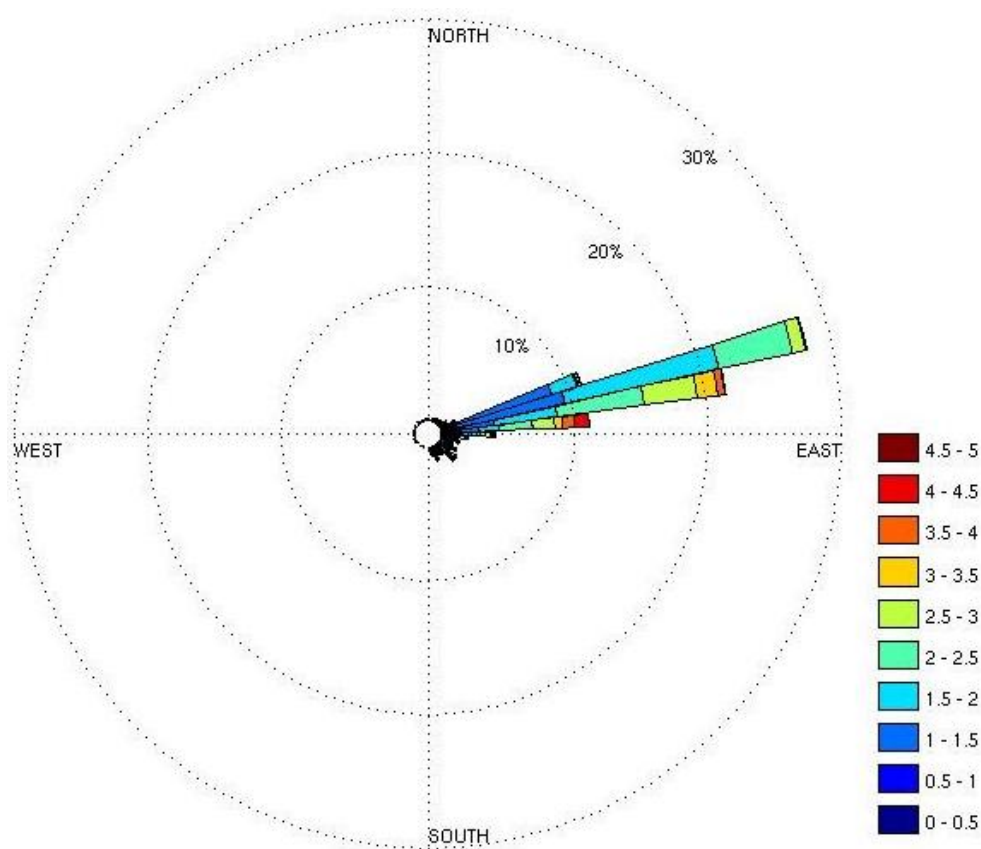
Figure 5.9. Percentage frequency wave height and wave direction from the 1st August 2011 to 5th March

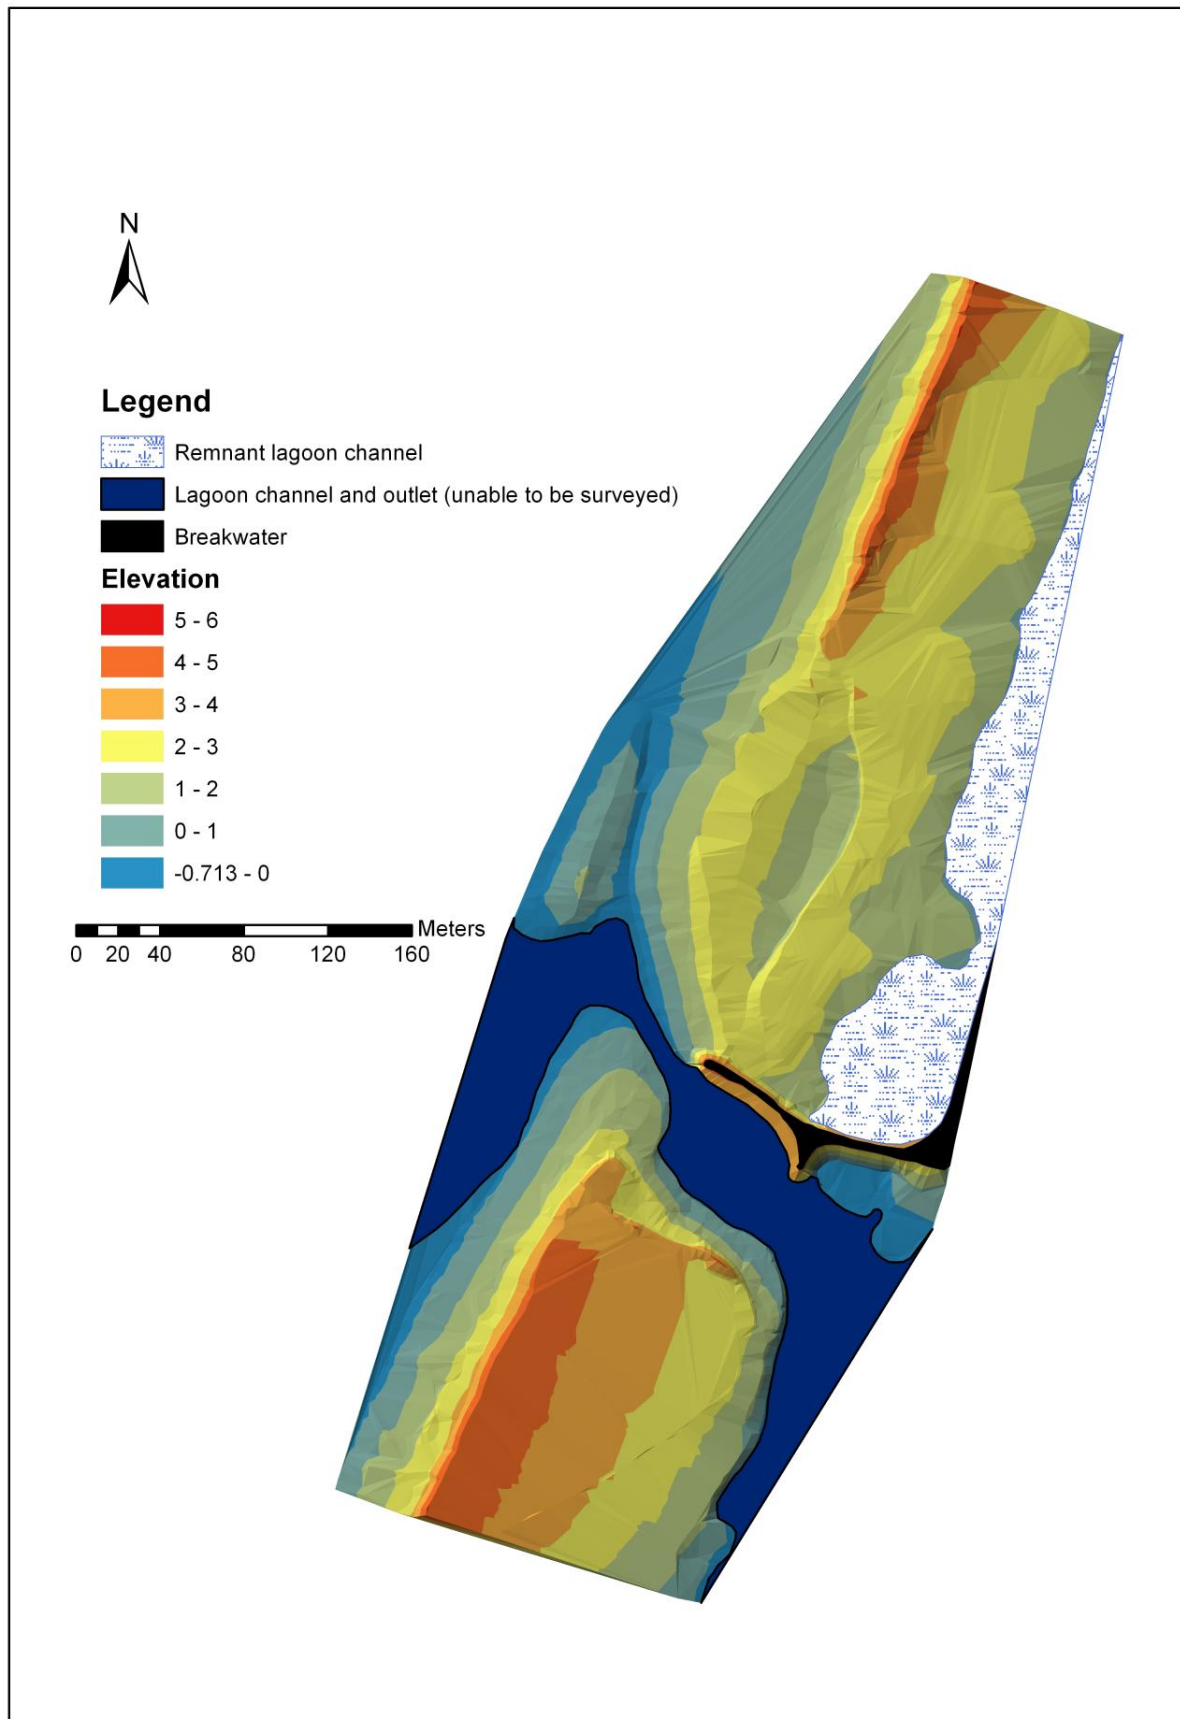
Figure 5.10. Topography of the New River Lagoon outlet and immediate updrift and downdrift beaches relative to mean sea level

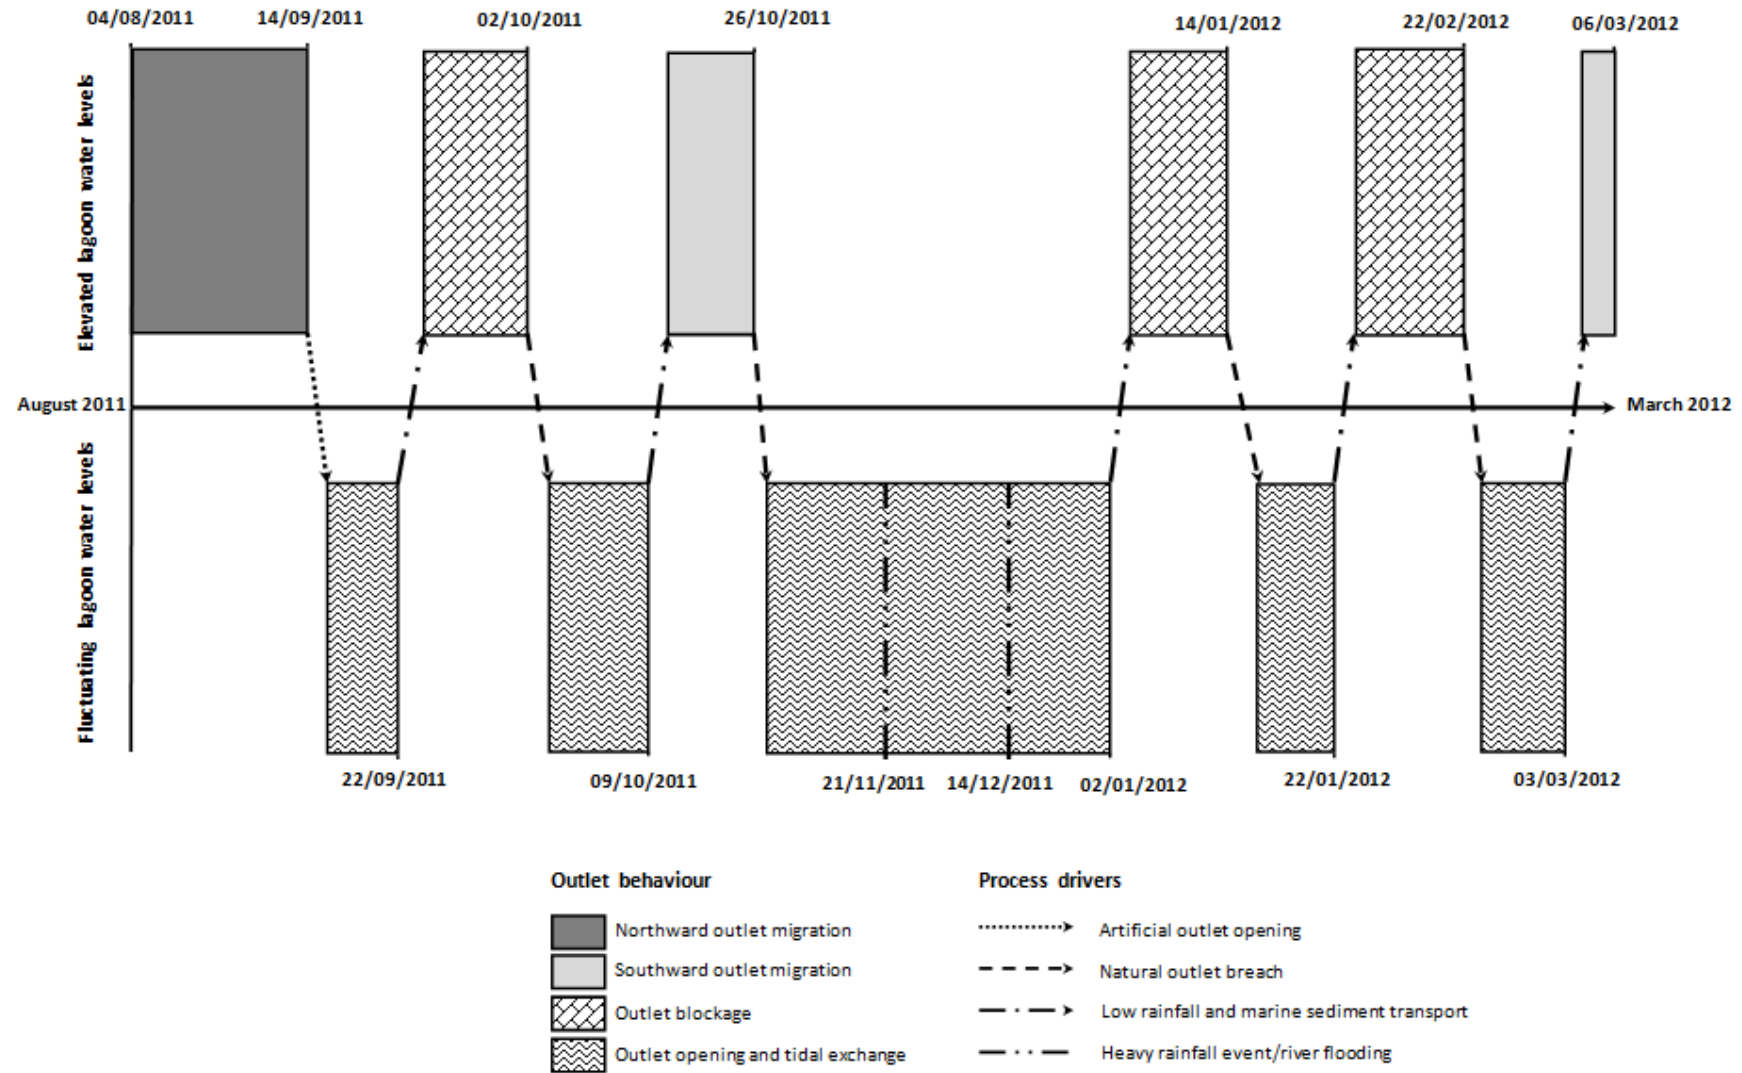
Figure 5.11. Timeline of morphological outlet behaviour and process drivers and associated hydrological dynamics at the New River Lagoon between August 2011 and March 2012

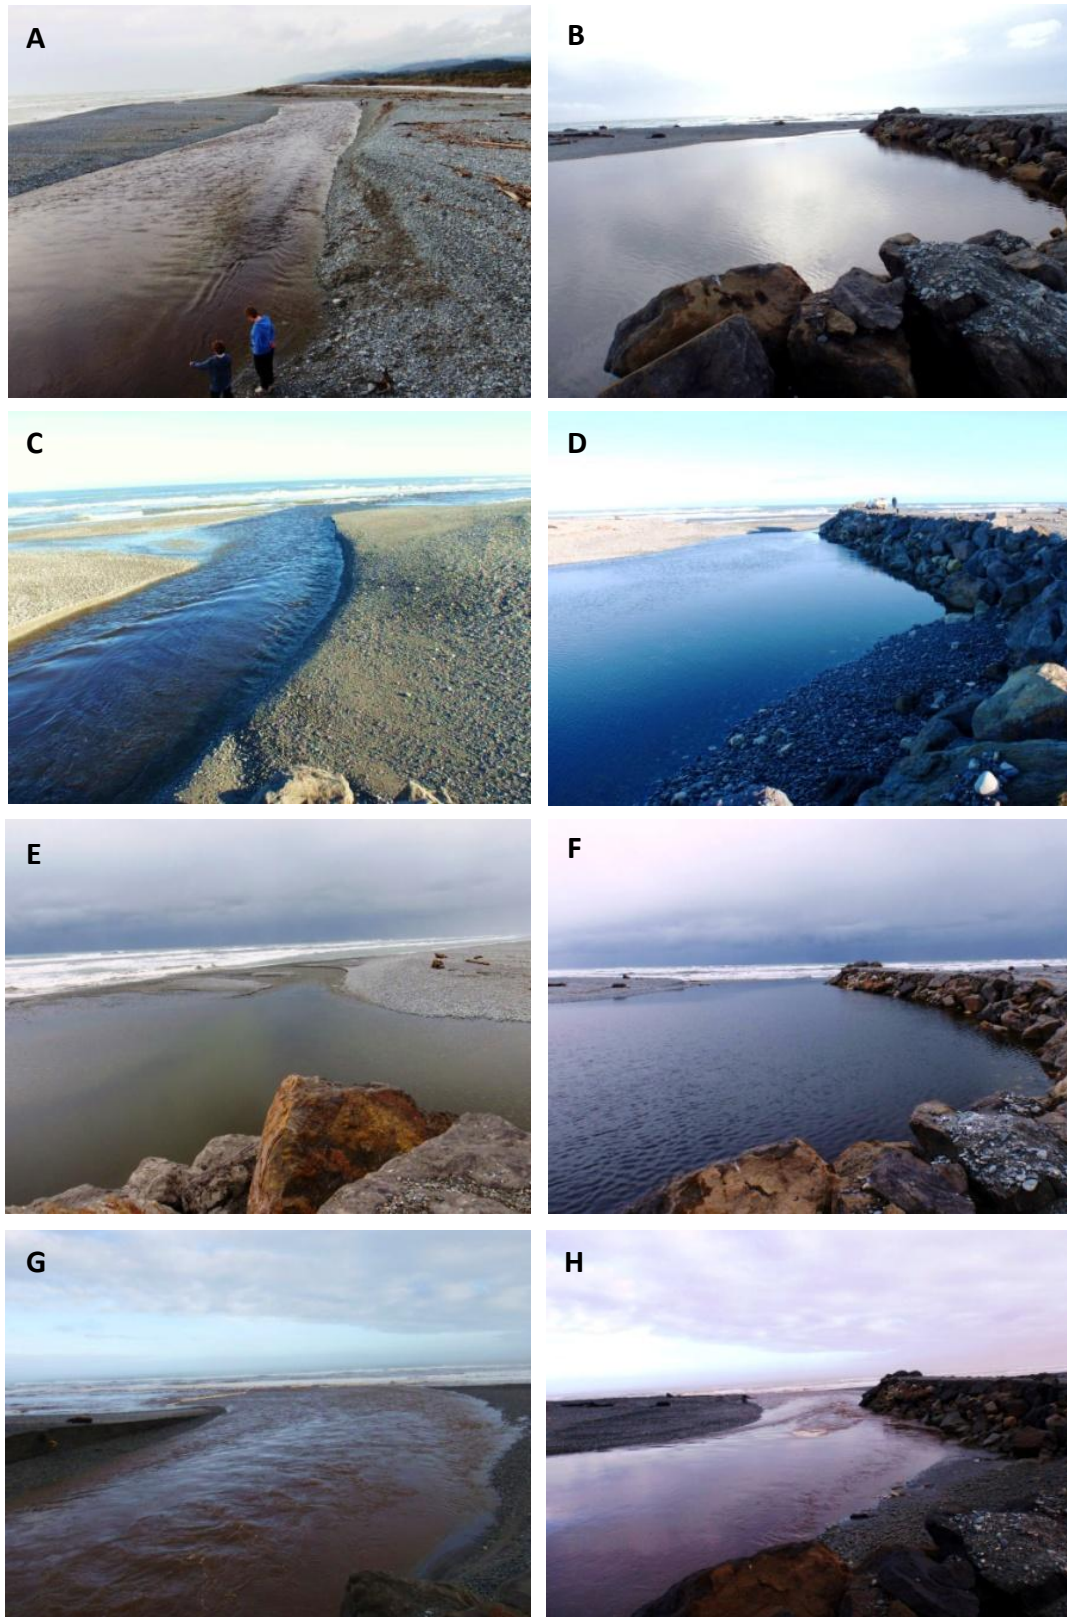
Figure 5.12. Outlet morphology on 10/09/2011 (A, B), 18/09/2011 (C, D), 25/09/2011 (E, F), and 02/10/2011 (G, H) (Photos courtesy of Karl Tolley). Images A and B show northward drift of the lagoon outlet and the subsequent high water levels in the reservoir of the lagoon outlet. Images C and D shows the lagoon outlet 4 days after artificial opening whereby lagoon water levels decrease considerably. Note the nearshore sediment bar in the background of photo B that likely contributed to outlet blockage. Images E and F show blockage of the lagoon outlet 11 days after artificial opening whereby high water levels pond behind the barrier beach. Images G and H show natural lagoon breach following lagoon blockage

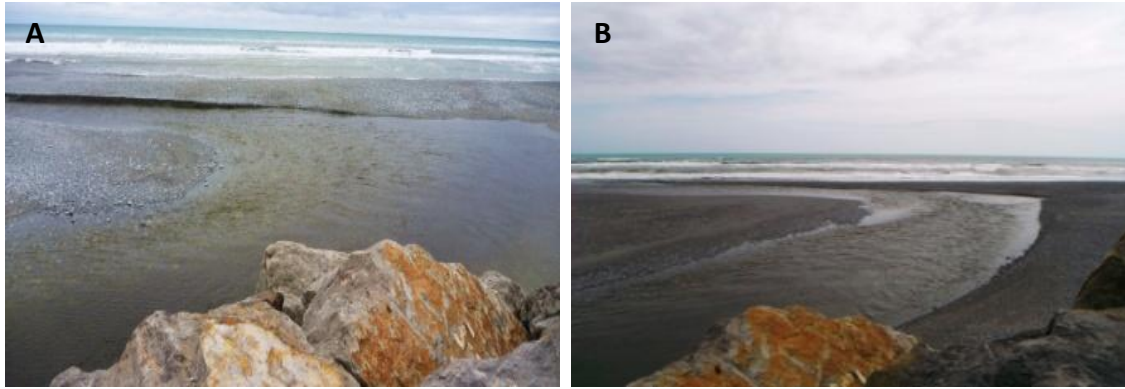
Figure 5.13. Southward outlet migration on the 24/10/2011 (image A) and 06/03/2012 (image B) (Photos courtesy of Charlie Teasdale)

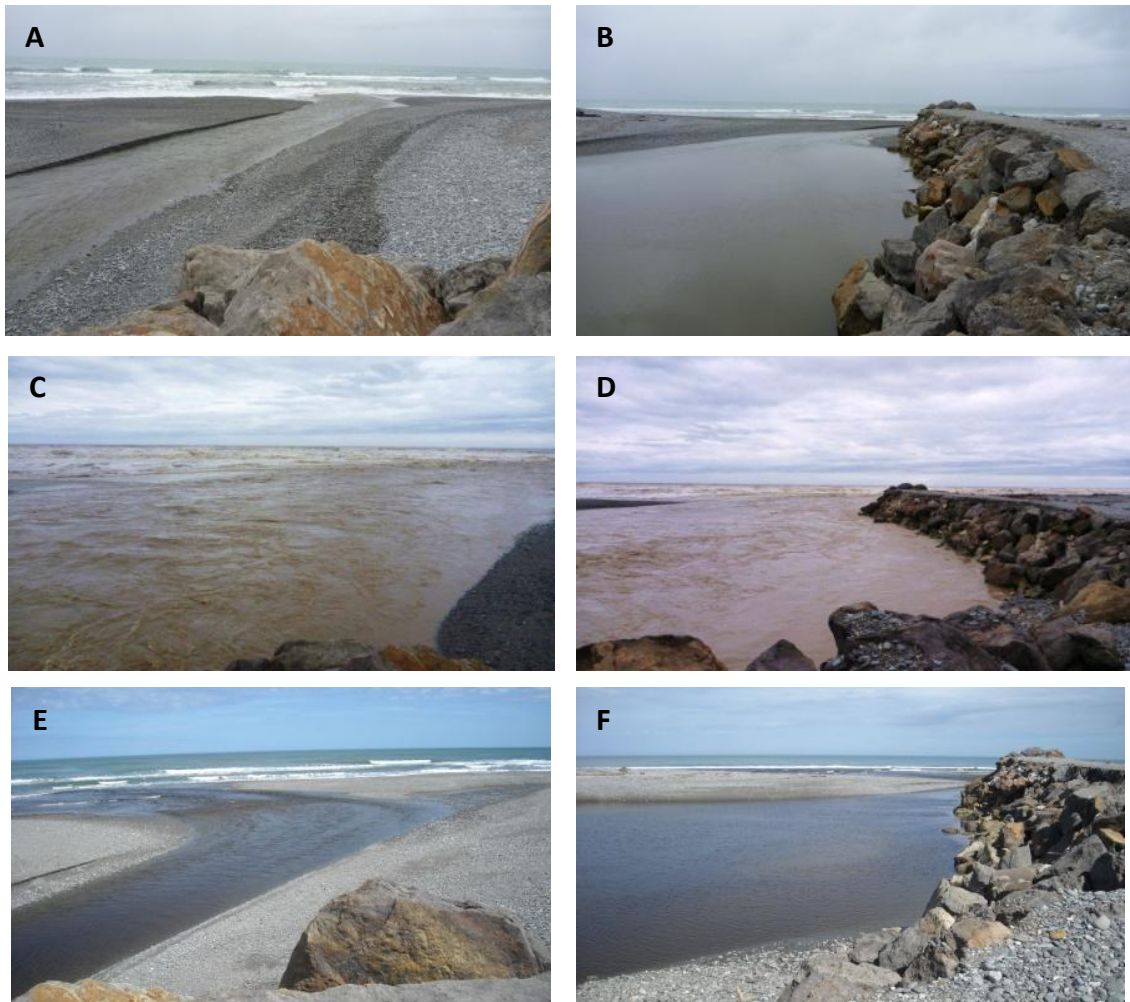
Figure 5.14. Outlet morphology on 20/11/2011 (A, B), 21/11/2011 (C, D), and 02/12/2011 (E, F) (Photos courtesy of Charlie Teasdale). Images A and B show the general direct outlet position for November and December 2011. Images C and D show flooding of the lagoon causing increased water levels and widening of the outlet and images E and F show the lagoon outlet following flooding.

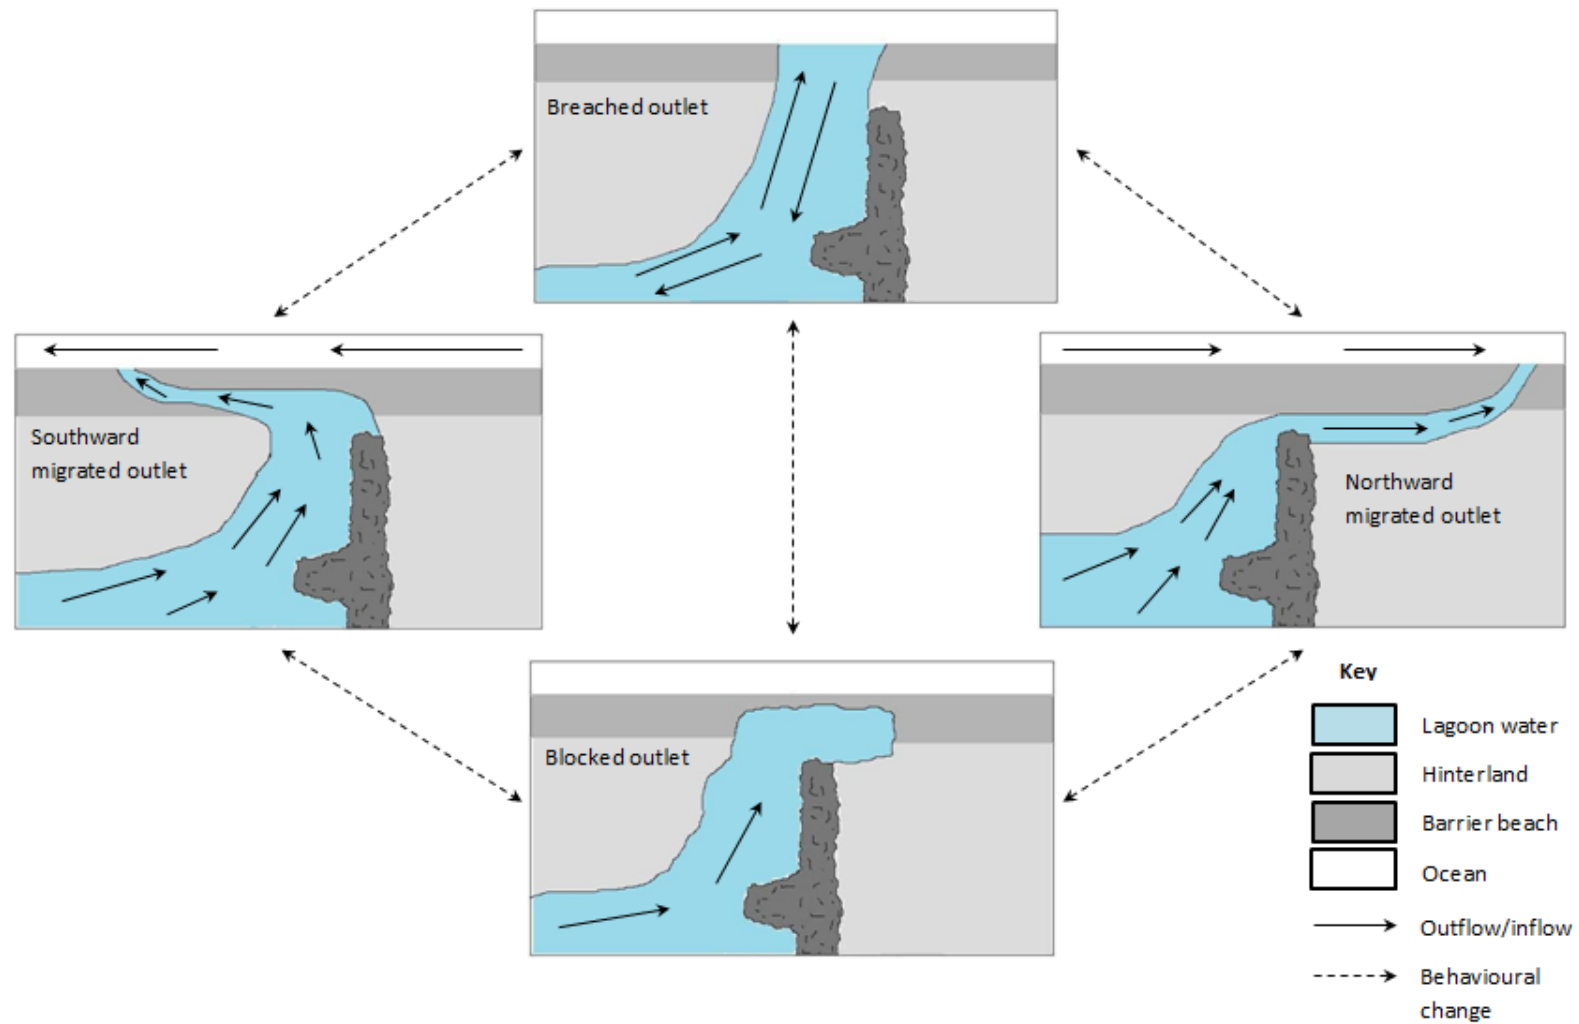
Figure 6.1. Typical outlet states at the New River Lagoon post-engineering management cycled between phases of outlet breach, outlet blockage and outlet migration, which determined inflows and outflows into the system. This is largely controlled by the obstruction of the rubble-mound breakwater.

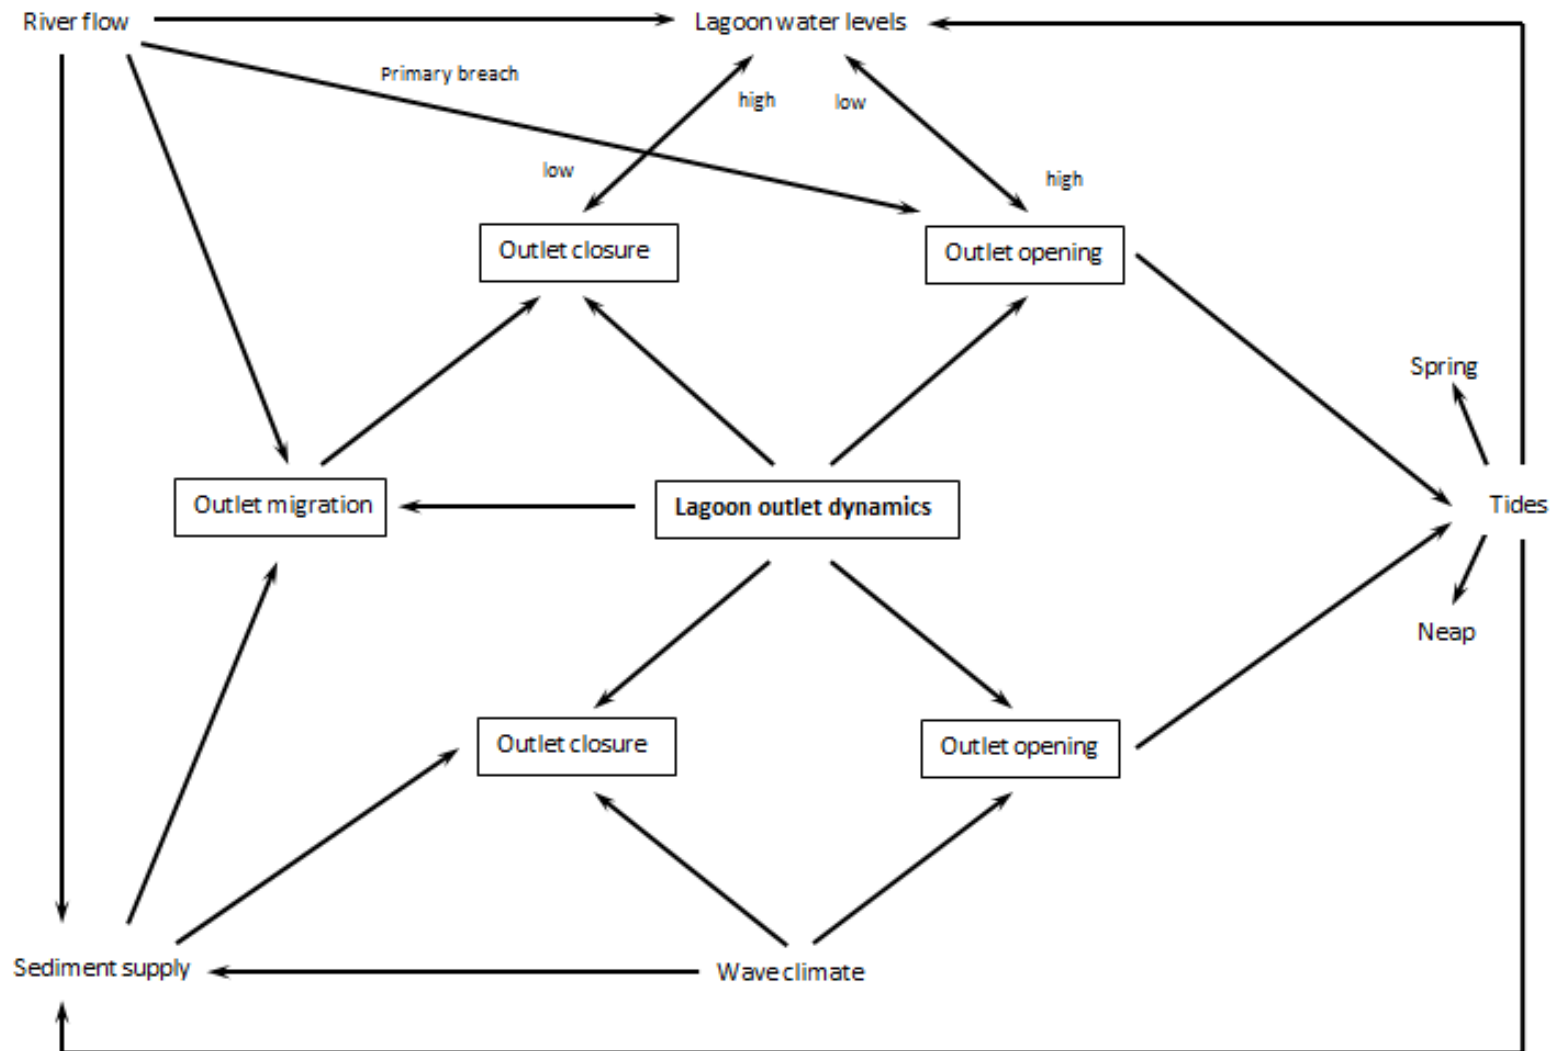
Figure 6.2. New River Lagoon outlet dynamics in response to different process agents following engineering management

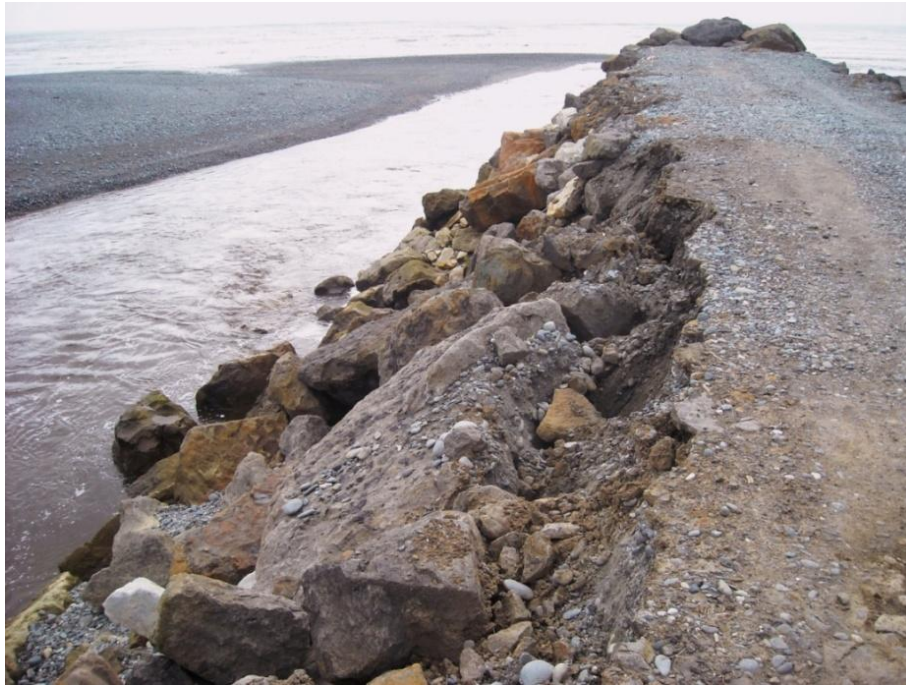
Figure 6.4. Slumping of the southern side of the engineering breakwater at the outlet of the New River Lagoon (27/10/2011)

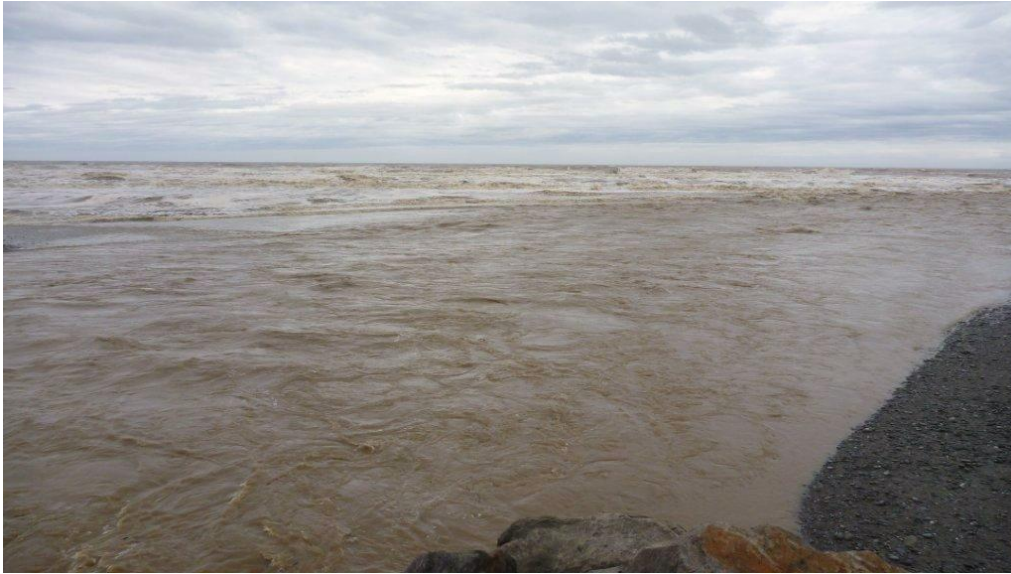
Figure 6.5. Seaward view of from the breakwater at the New River Lagoon showing opposing outflowing river water during flood conditions and inflowing marine waves (photo courtesy of Charlie Teasdale, 21/11/2011)

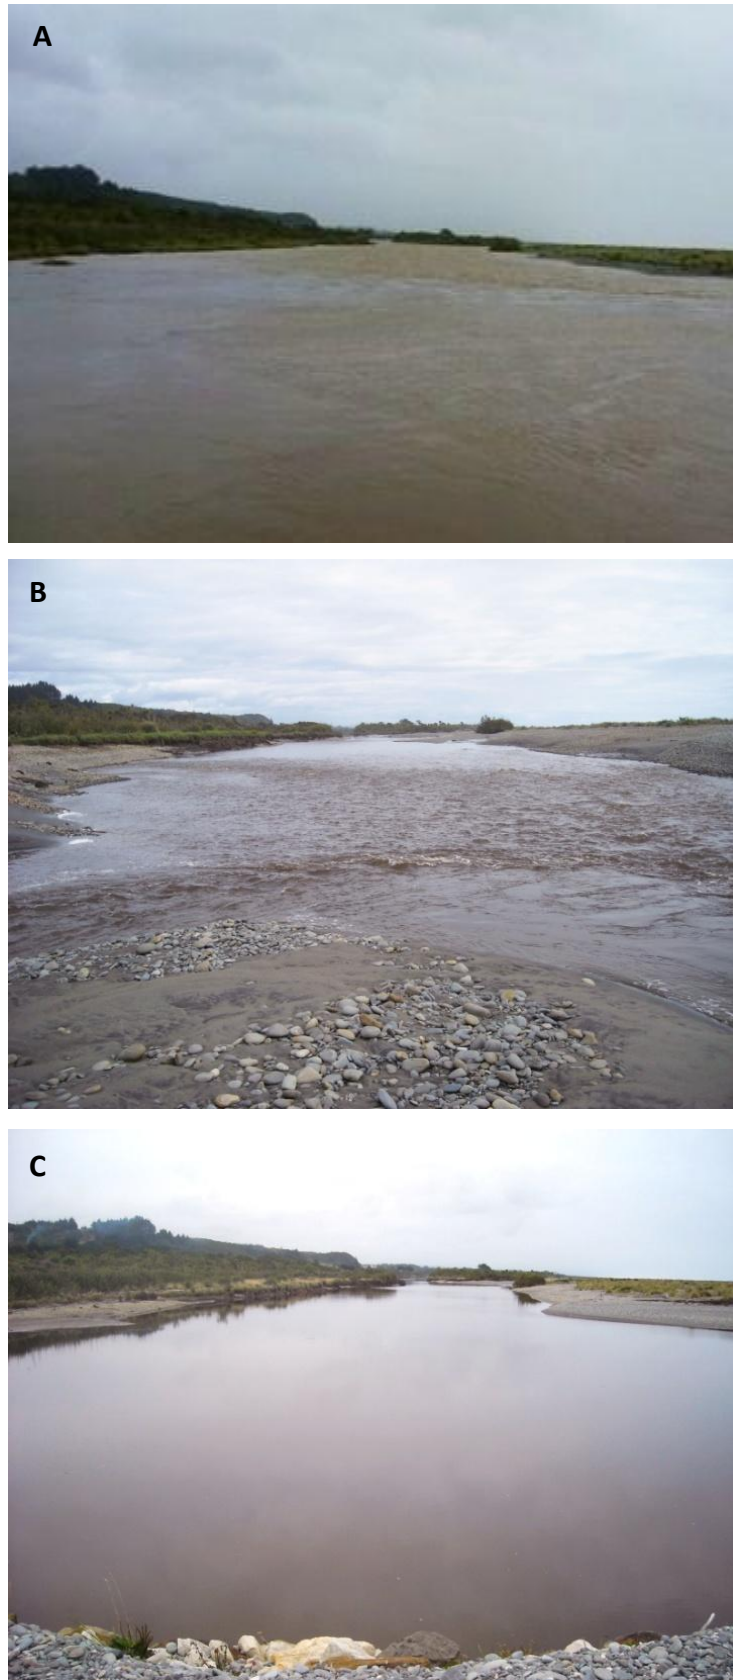
Figure 6.6. Change in lagoon water levels at the New River lagoon during flood conditions (image A, 14/12/2011, Photo courtesy of Charlie Teasdale), following flooding (image B, 27/10/2011) and during steady open outlet conditions (image C, 2/3/2012).
